**Institute of Geologists of Ireland
Pyrite Course**

I.S. 398-1: What's in it and the role of the Geologist

Michael L.J. Maher
4 December, 2013

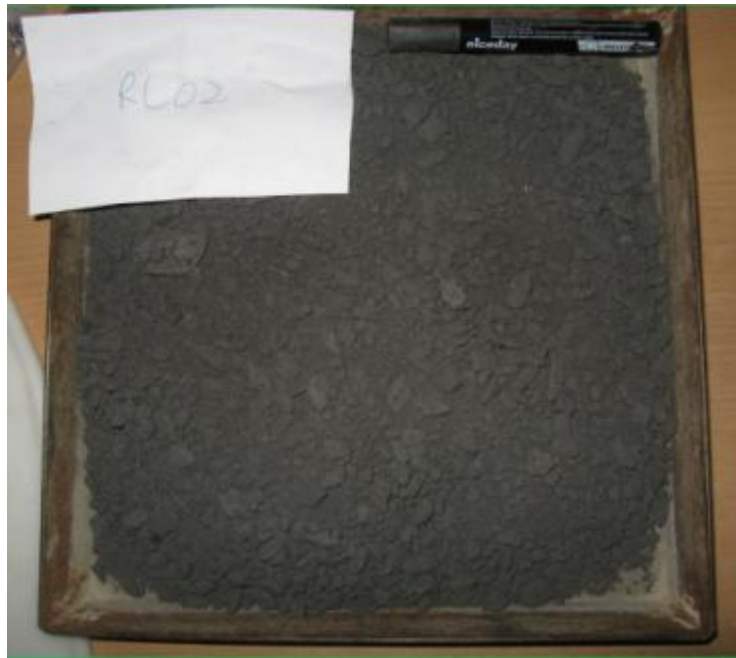
Lithological Description

Lithology 1 (95%):

Dark grey to black, calcareous siltstone/mudstone. The particles are platy, moderately weak, laminated and sub-angular. The particles show outer surface coatings consisting of fine material and recrystallisation deposits. The particles reacted with 10% HCl, indicating the presence of calcite. Gypsum crystals were observed on freshly opened laminations.

Lithology 2 (5%):

Dark grey, medium grey massive limestone, showing similar coatings to those described in lithology 1.
